# **The Road Inventory of Eastern Shore of Virginia National Wildlife Refuge Cape Charles, VA**

Prepared By:  
Federal Highway Administration  
Central Federal Lands Highway Division  
October, 2010

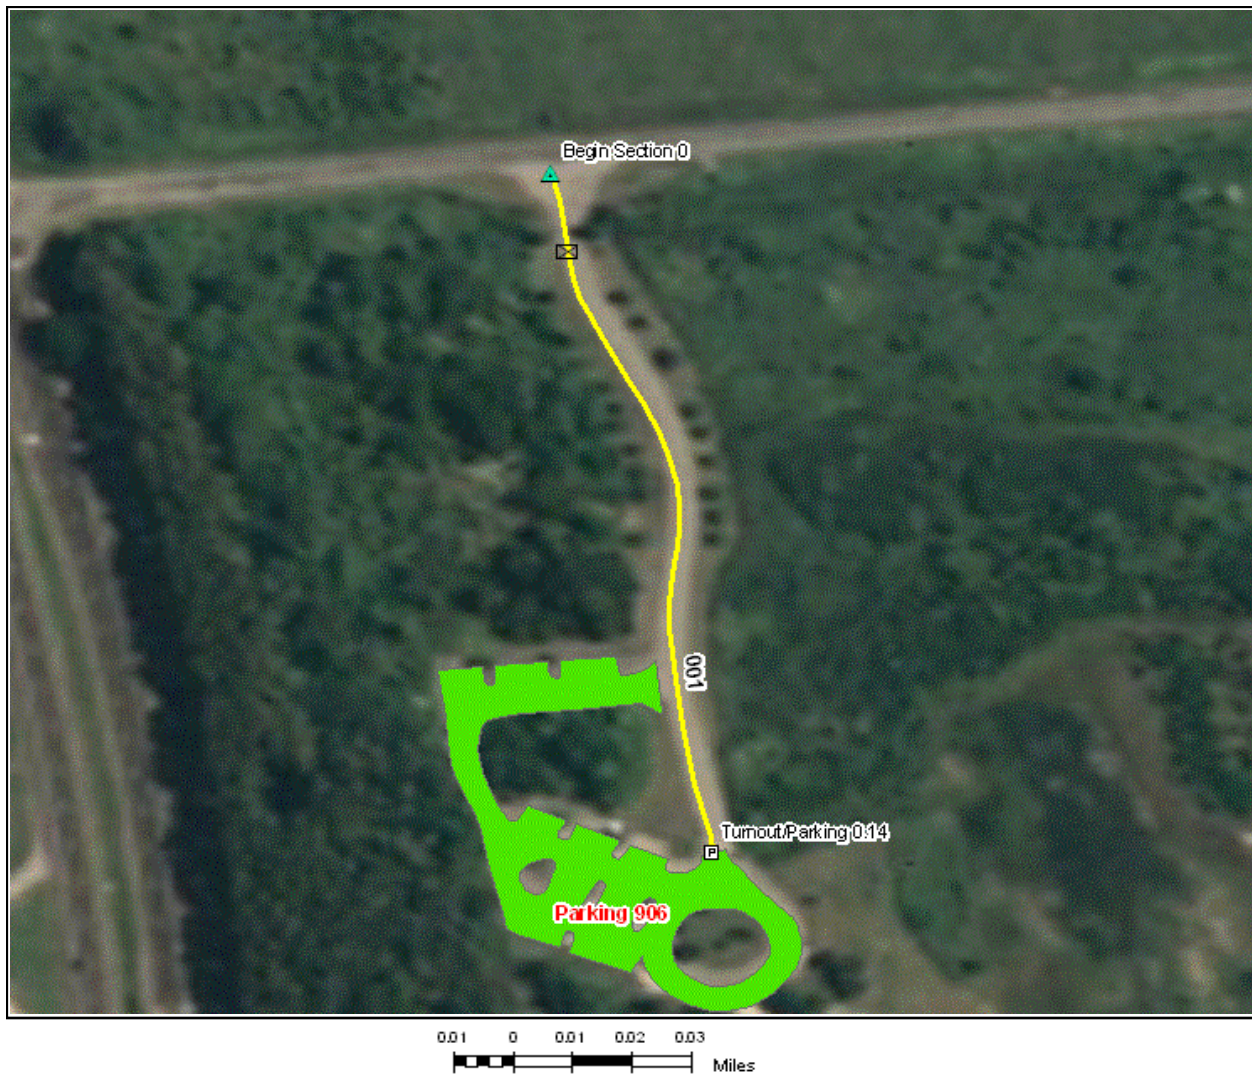
Route: 010 Visitor Center Access Road

Total Route Length: **0.14 Miles**

Route Description: From Seaside Road to Visitor Center Parking (Route 906)

Asset Number	10021825
Section Number	001
Section Length (miles)	0.14
Inspection Date	06/02/2010
<b>Section Information</b>	
Surface Type	Asphalt
Number of Lanes	2
Roadway Width (feet)	22.00
<b>Roadway Condition Information</b>	
Condition	Fair
Remaining Service Life (years)	8
Cost Estimate	14,900
CRV	165,100.00

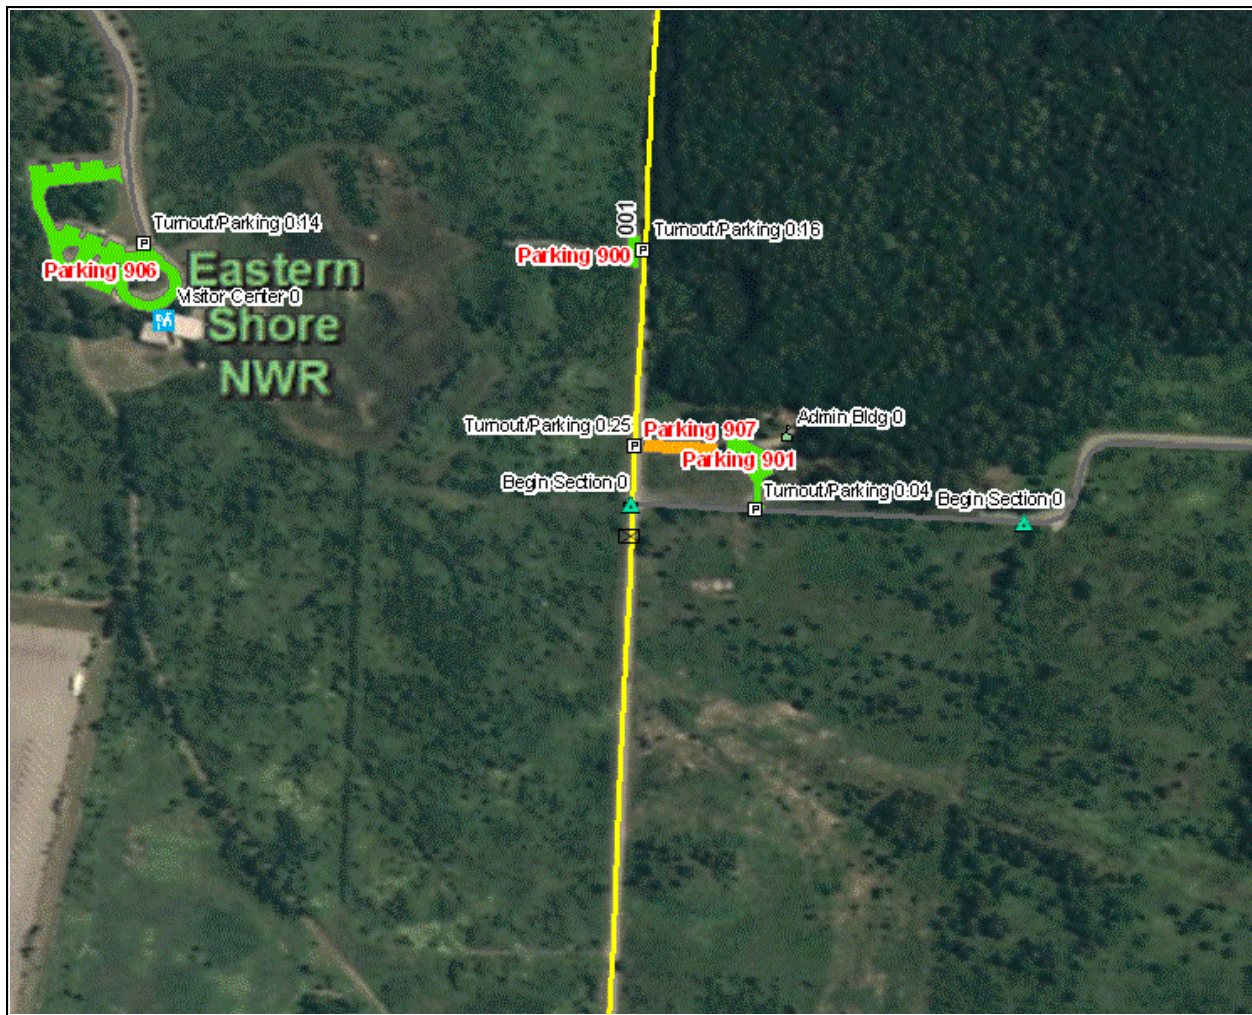
Route: 011 Fitchett Road

Total Route Length: **0.56 Miles**

Route Description: From Seaside Road to Wildlife Trail Access Road (Route 101)

Asset Number	10021825
Section Number	001
Section Length (miles)	0.56
Inspection Date	06/02/2010
<b>Section Information</b>	
Surface Type	Asphalt
Number of Lanes	2
Roadway Width (feet)	18.00
<b>Roadway Condition Information</b>	
Condition	Fair
Remaining Service Life (years)	8
Cost Estimate	59,600
CRV	660,600.00

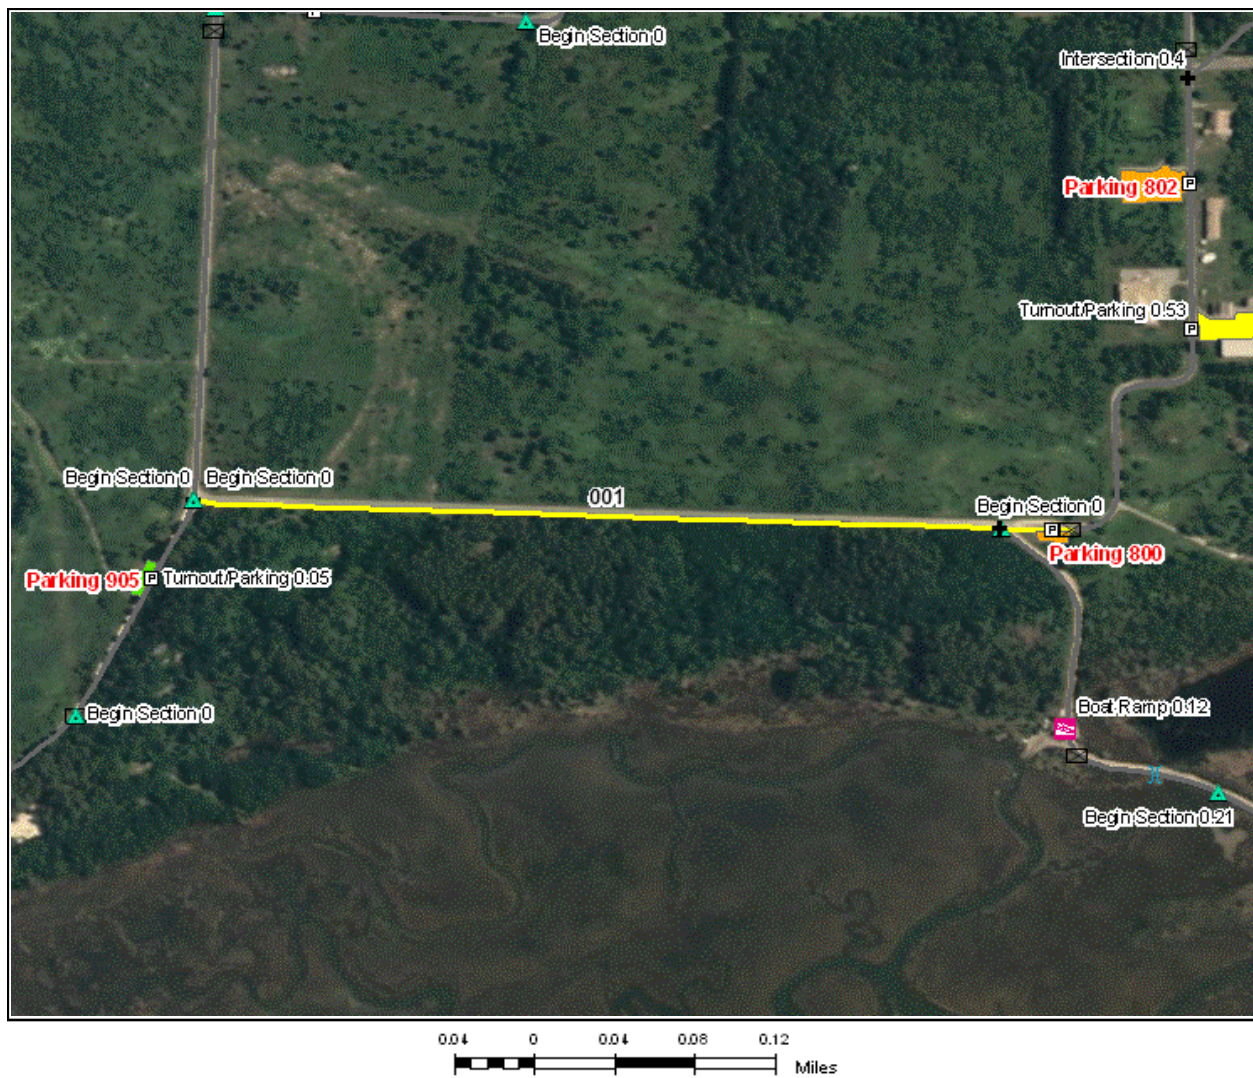
Route: 012 Hallett South Road

Total Route Length: 0.40 Miles

Route Description: From Fitchett Road (Route 011) to Hallett Circle Road (Route 401)

Asset Number	10021825
Section Number	001
Section Length (miles)	0.40
Inspection Date	06/02/2010
<b>Section Information</b>	
Surface Type	Asphalt
Number of Lanes	2
Roadway Width (feet)	18.00
<b>Roadway Condition Information</b>	
Condition	Fair
Remaining Service Life (years)	8
Cost Estimate	42,600
CRV	471,800.00

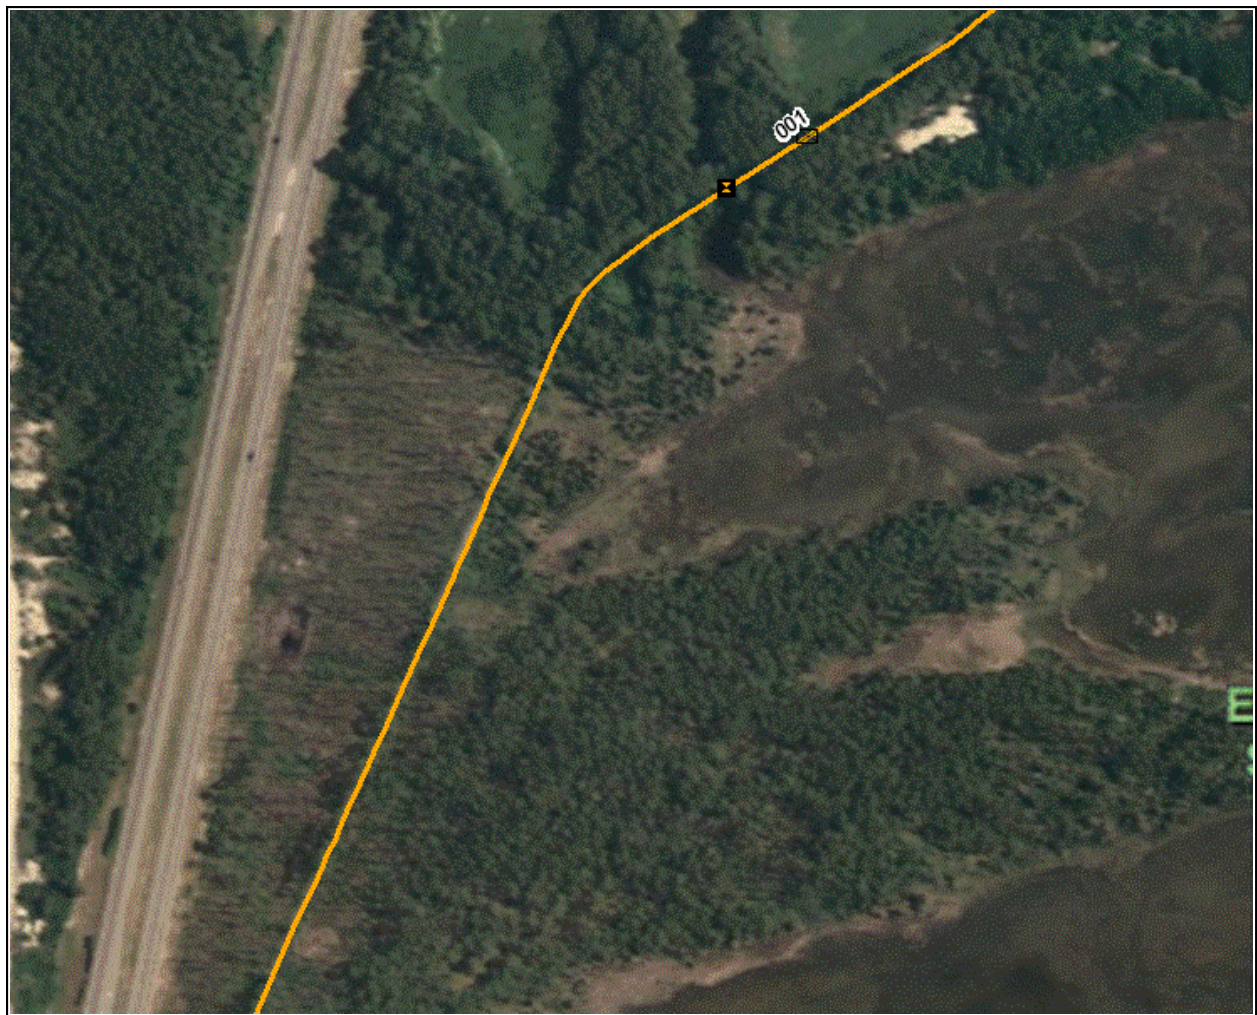
Route: 400 Wise Point Road

Total Route Length: **0.58 Miles**

Route Description: From Wildlife Trail Access Road (Route 101) to end of route

Asset Number	10054403
Section Number	001
Section Length (miles)	0.58
Inspection Date	06/02/2010
<b>Section Information</b>	
Surface Type	Asphalt
Number of Lanes	1
Roadway Width (feet)	12.00
<b>Roadway Condition Information</b>	
Condition	Poor
Remaining Service Life (years)	6
Cost Estimate	337,100
CRV	684,200.00

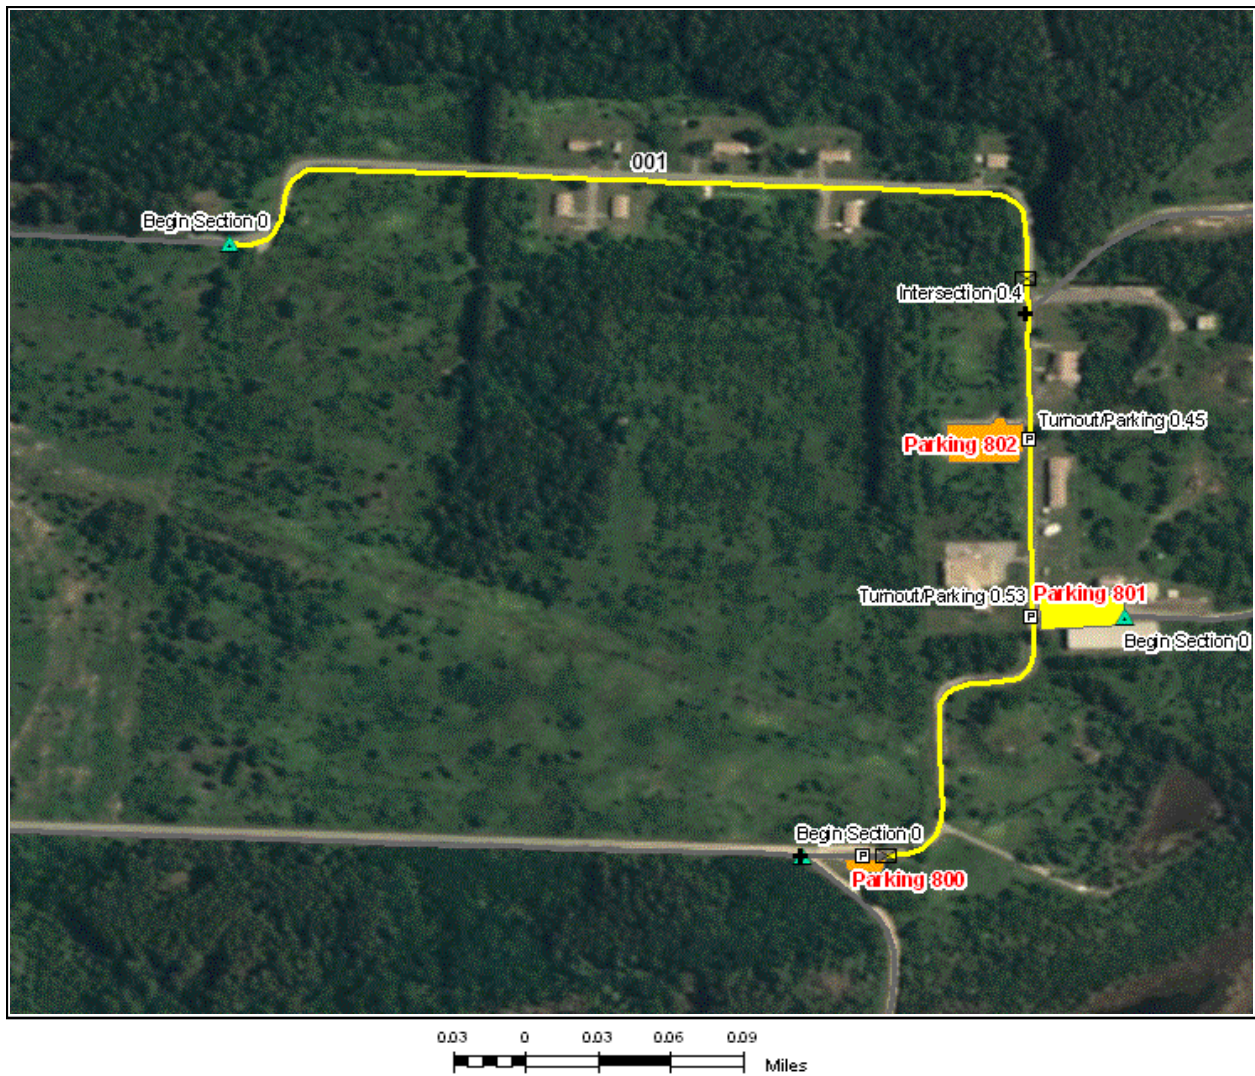
Route: 401 Hallett Circle Road

Total Route Length: **0.67 Miles**

Route Description: From Refuge Headquarters Access Road (Route 100) to Hallett South Road (Route 012)

Asset Number	10021826
Section Number	001
Section Length (miles)	0.67
Inspection Date	06/02/2010
<b>Section Information</b>	
Surface Type	Asphalt
Number of Lanes	2
Roadway Width (feet)	18.00
<b>Roadway Condition Information</b>	
Condition	Fair
Remaining Service Life (years)	8
Cost Estimate	71,400
CRV	790,300.00

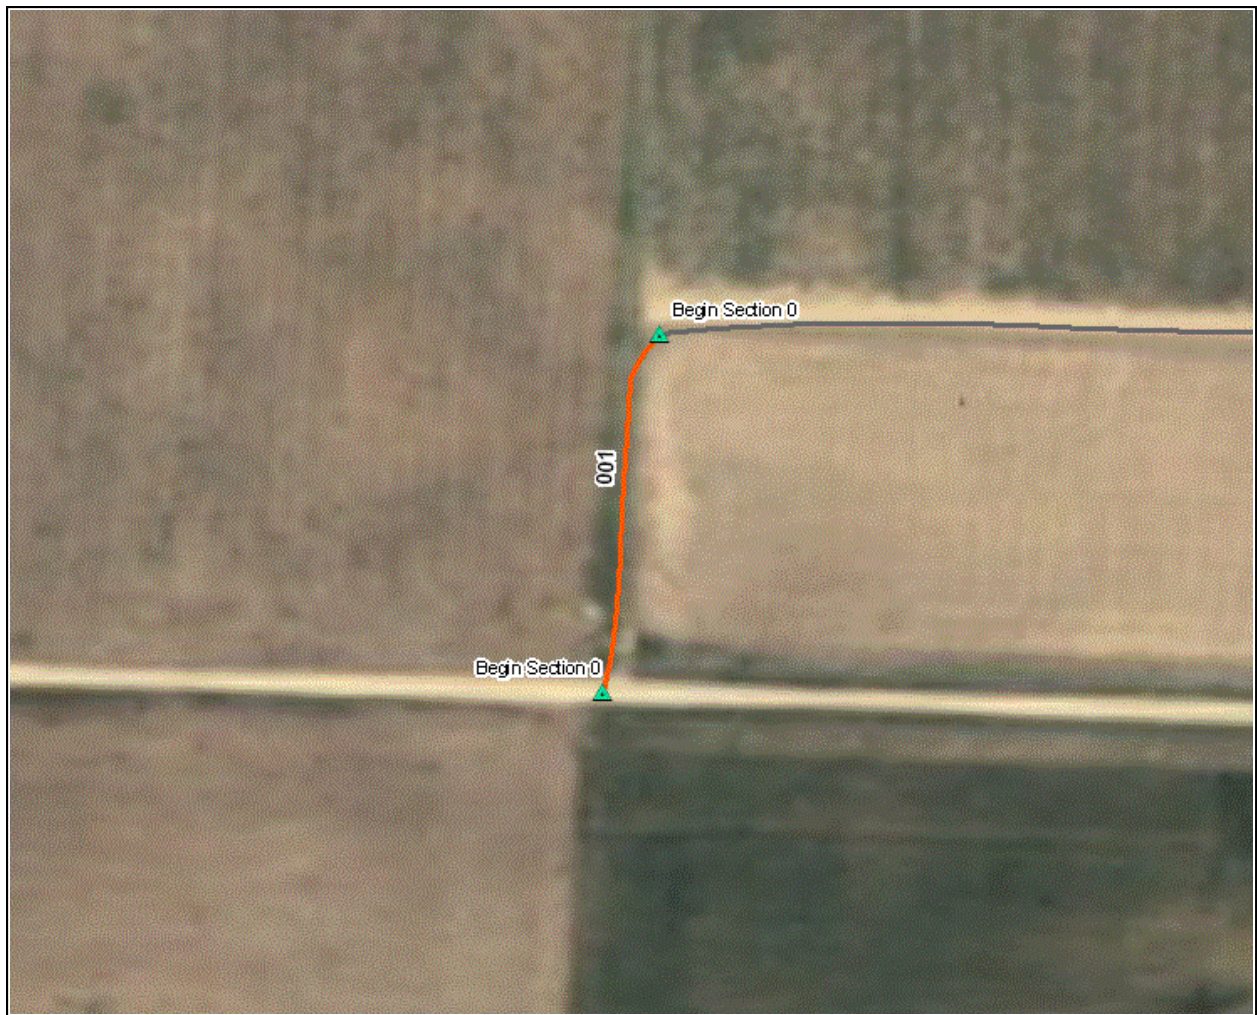
Route: 403 Bull's Lane A

Total Route Length: **0.06 Miles**

Route Description: From Bulls Drive to end of route

Asset Number	10058041
Section Number	001
Section Length (miles)	0.06
Inspection Date	06/02/2010
<b>Section Information</b>	
Surface Type	Native
Number of Lanes	1
Roadway Width (feet)	12.00
<b>Roadway Condition Information</b>	
Condition	Failed
Remaining Service Life (years)	0
Cost Estimate	7,300
CRV	21,100.00

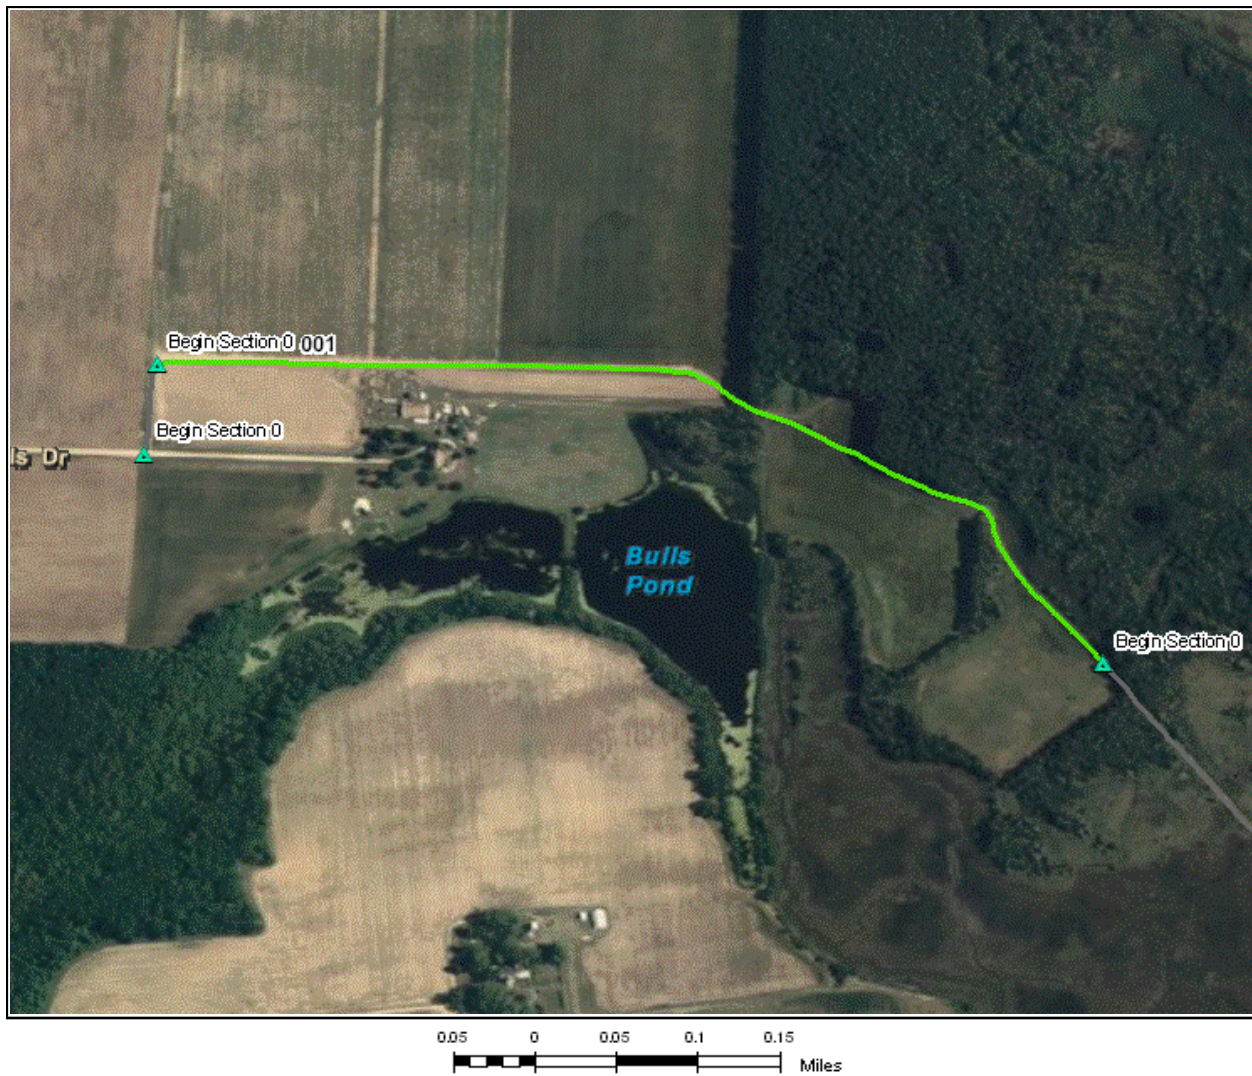
Route: 404 Bull's Lane B

Total Route Length: **0.62 Miles**

Route Description: From Bulls Drive to end of route

Asset Number	10058044
Section Number	001
Section Length (miles)	0.62
Inspection Date	06/02/2010
<b>Section Information</b>	
Surface Type	Native
Number of Lanes	1
Roadway Width (feet)	12.00
<b>Roadway Condition Information</b>	
Condition	Good
Remaining Service Life (years)	5
Cost Estimate	1,100
CRV	218,100.00

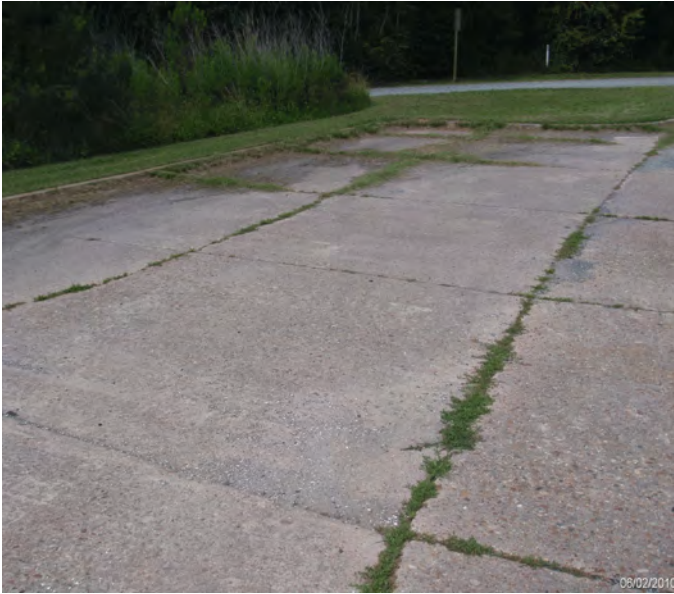
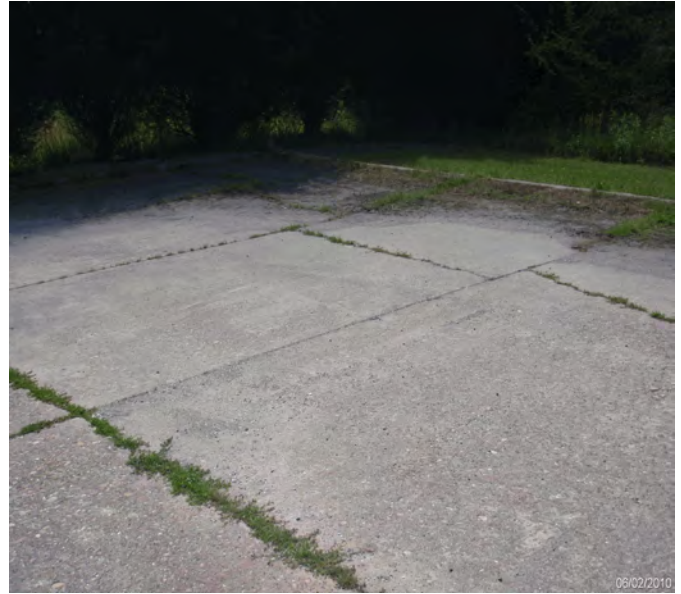
## 800: Guard House Parking

Asset Number	Date Visited	Surface Type	Area (Sq Ft)	Condition	Cost to Improve
10021847	06/02/2010	Concrete	2,455	Poor	11,100

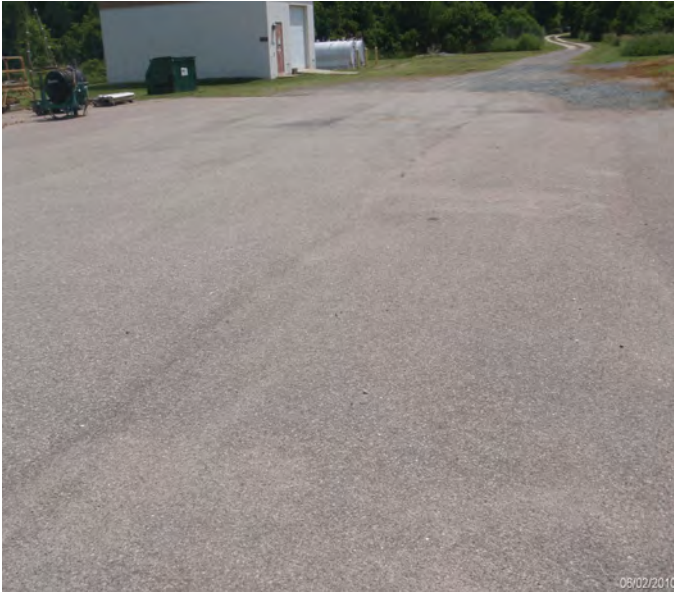
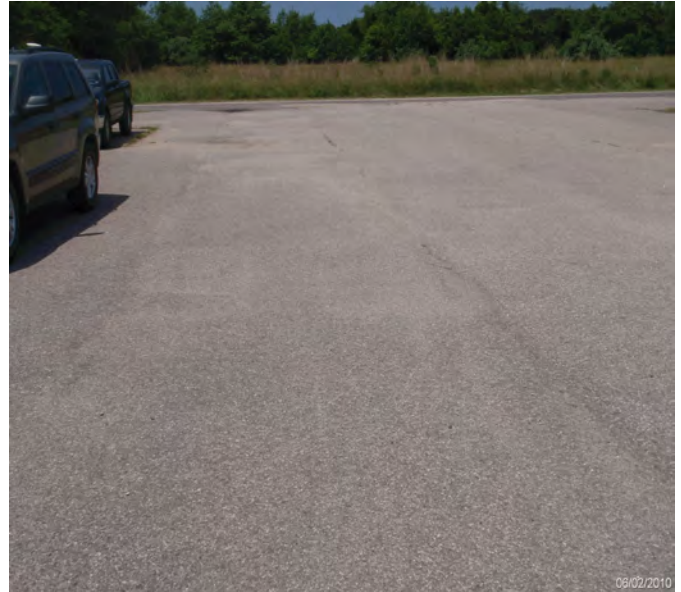
### 801: Maintenance Area Vehicle Parking Lot

Asset Number	Date Visited	Surface Type	Area (Sq Ft)	Condition	Cost to Improve
10021832	06/02/2010	Asphalt	12,739	Fair	10,800

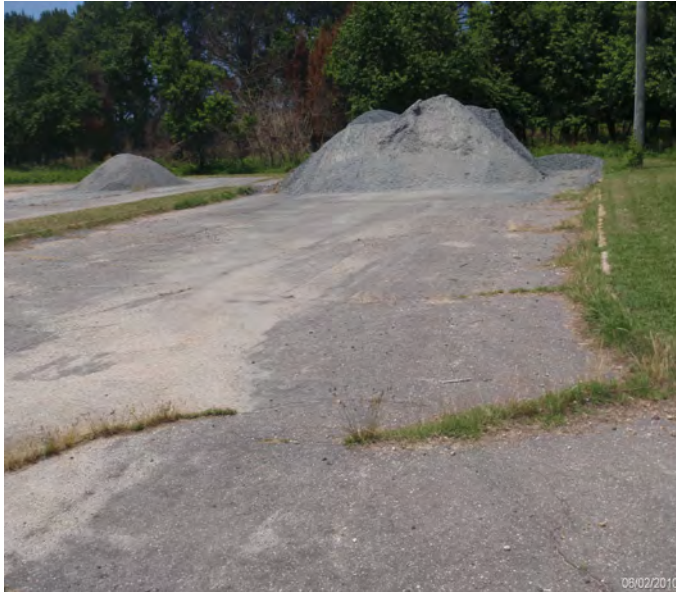
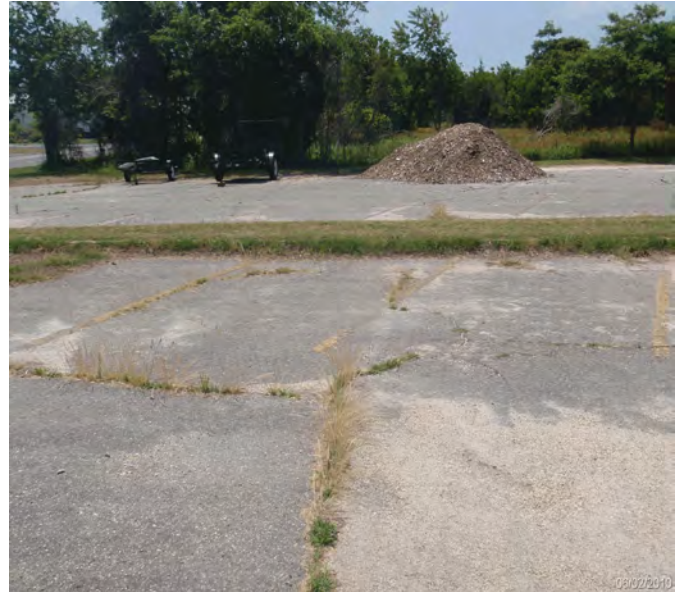
## 802: Training Conference Center Parking

Asset Number	Date Visited	Surface Type	Area (Sq Ft)	Condition	Cost to Improve
10021830	06/02/2010	Asphalt	15,268	Poor	72,100

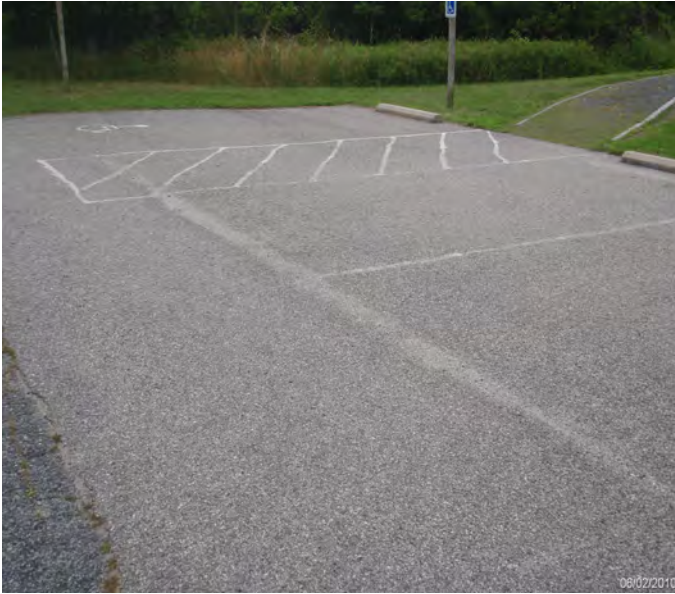
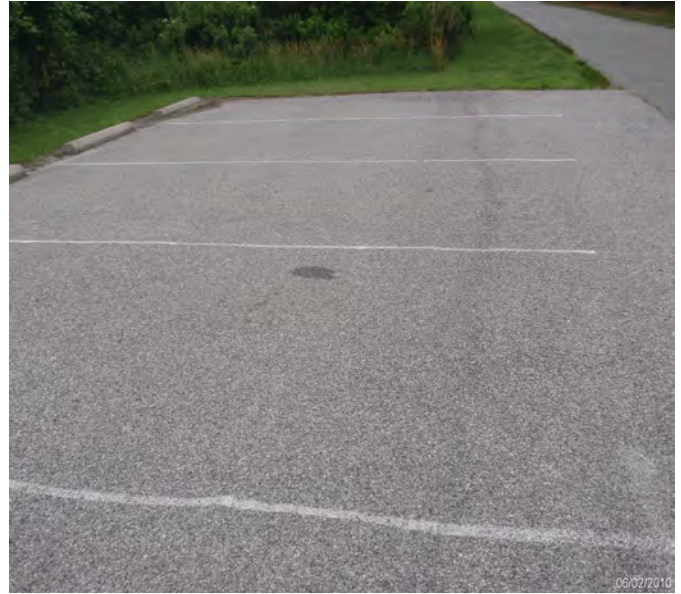
### 900: Photo Blind Parking

Asset Number	Date Visited	Surface Type	Area (Sq Ft)	Condition	Cost to Improve
10021839	06/02/2010	Asphalt	2,110	Good	400

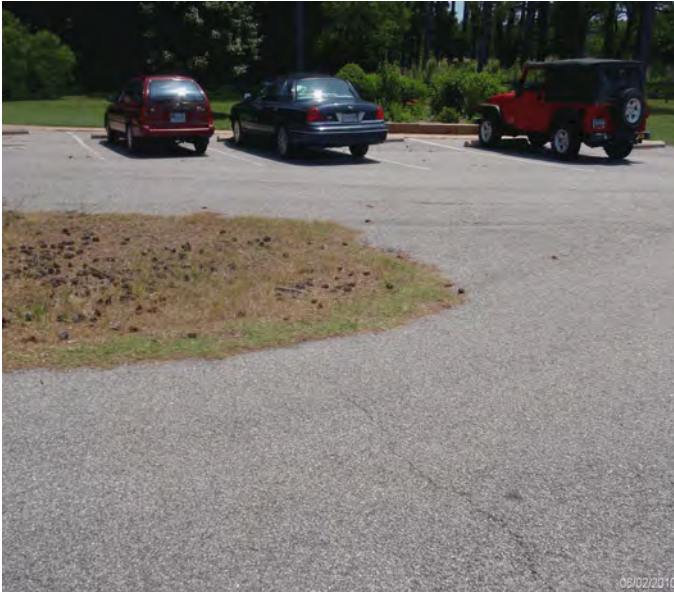
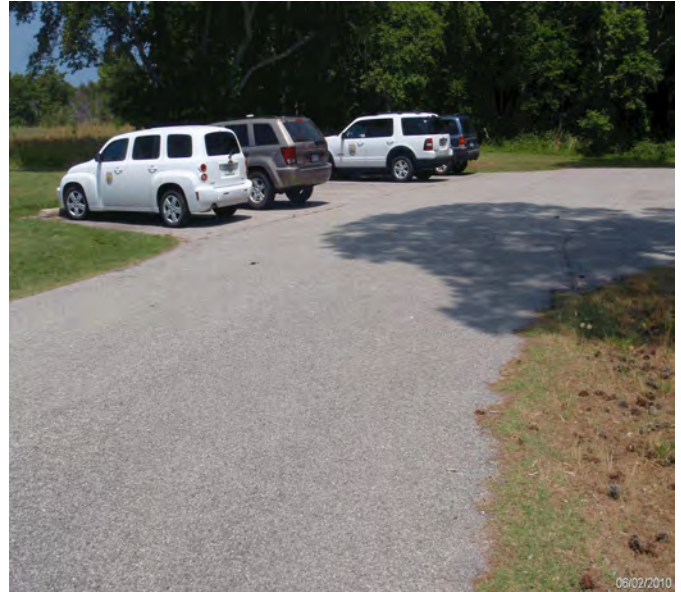
## 901: Headquarters Parking

Asset Number	Date Visited	Surface Type	Area (Sq Ft)	Condition	Cost to Improve
10021831	06/02/2010	Asphalt	8,349	Good	1,500

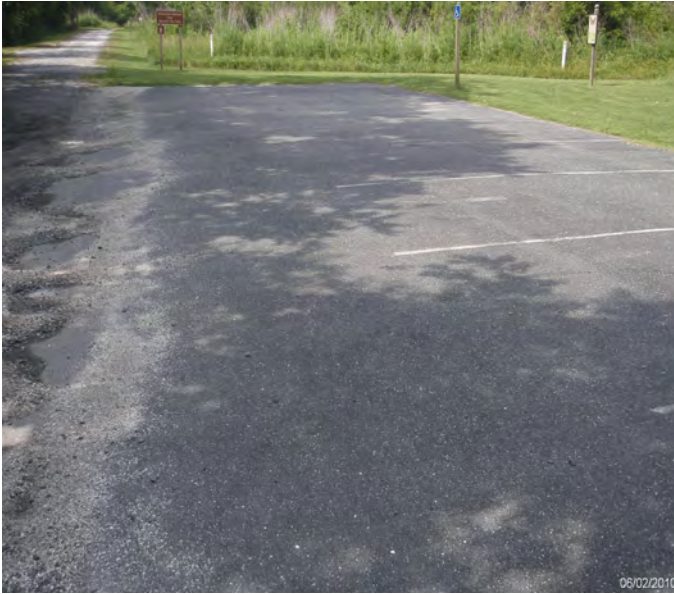
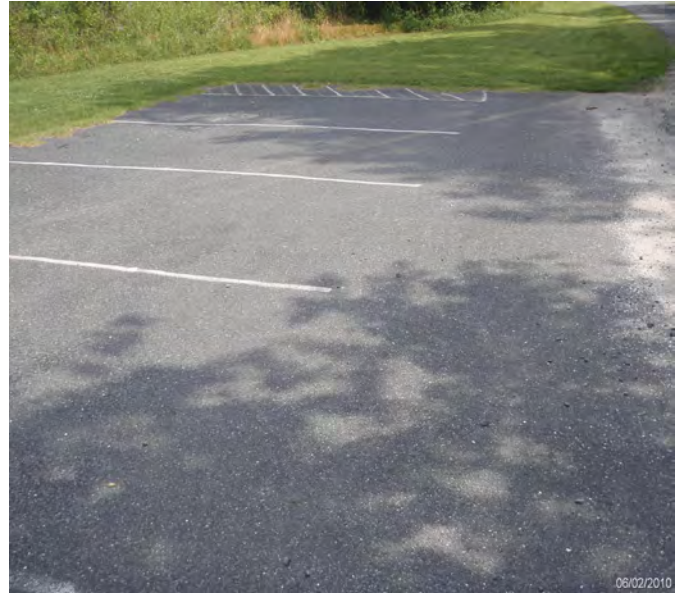
### 905: Wildlife Trail Parking

Asset Number	Date Visited	Surface Type	Area (Sq Ft)	Condition	Cost to Improve
10021833	06/02/2010	Asphalt	2,895	Good	500

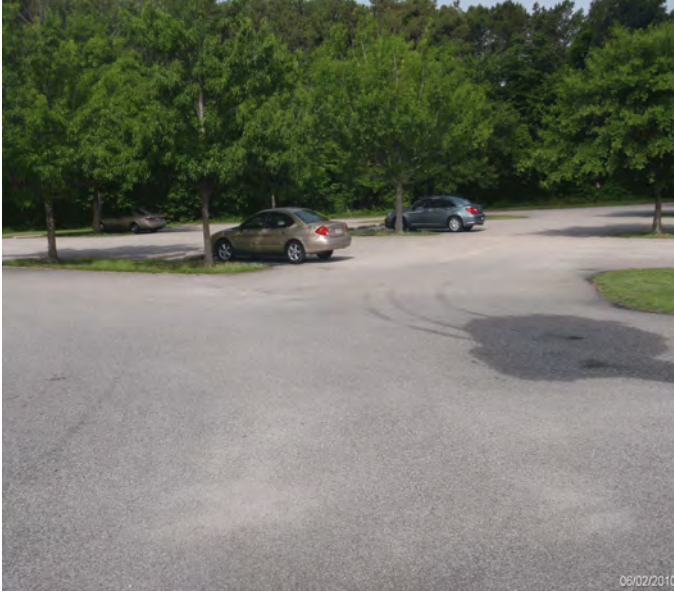
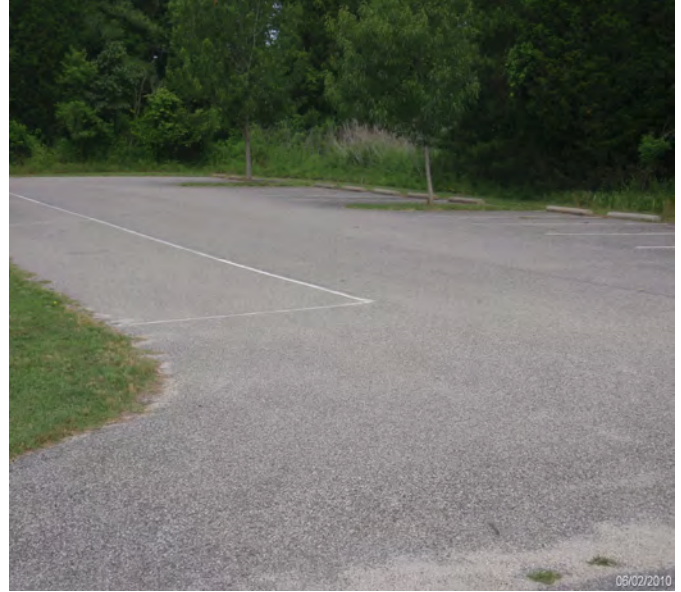
### 906: Visitor Center Parking

Asset Number	Date Visited	Surface Type	Area (Sq Ft)	Condition	Cost to Improve
10021828	06/02/2010	Asphalt	36,257	Good	6,600

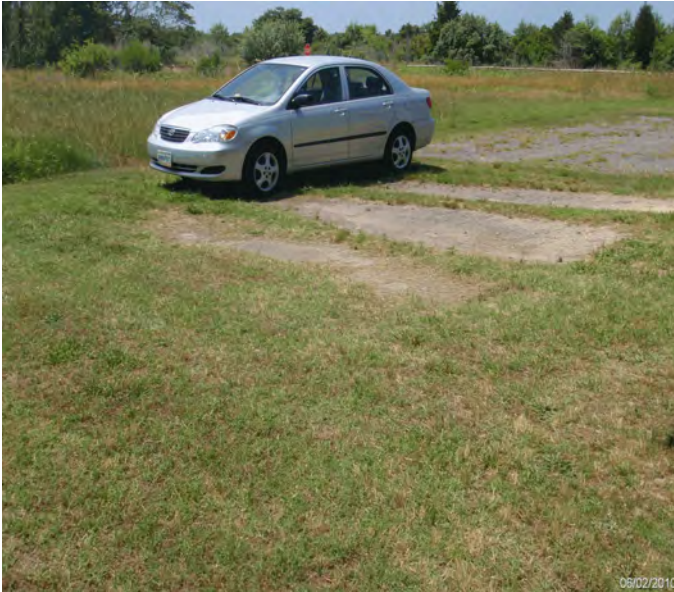
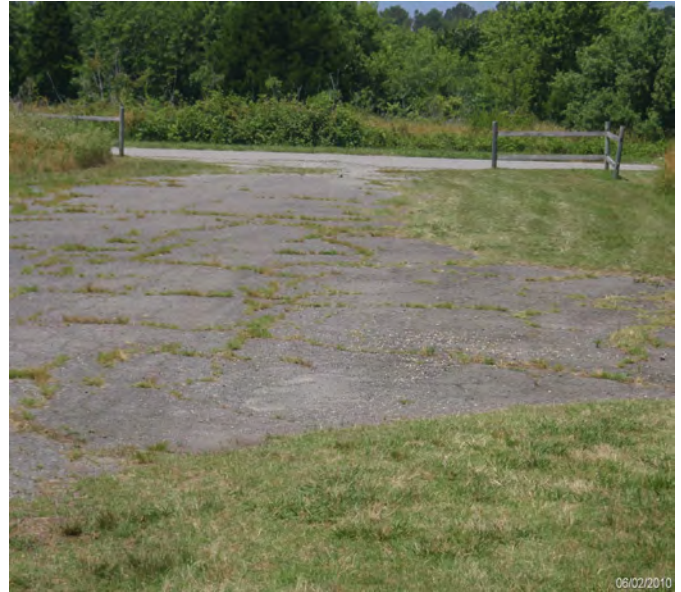
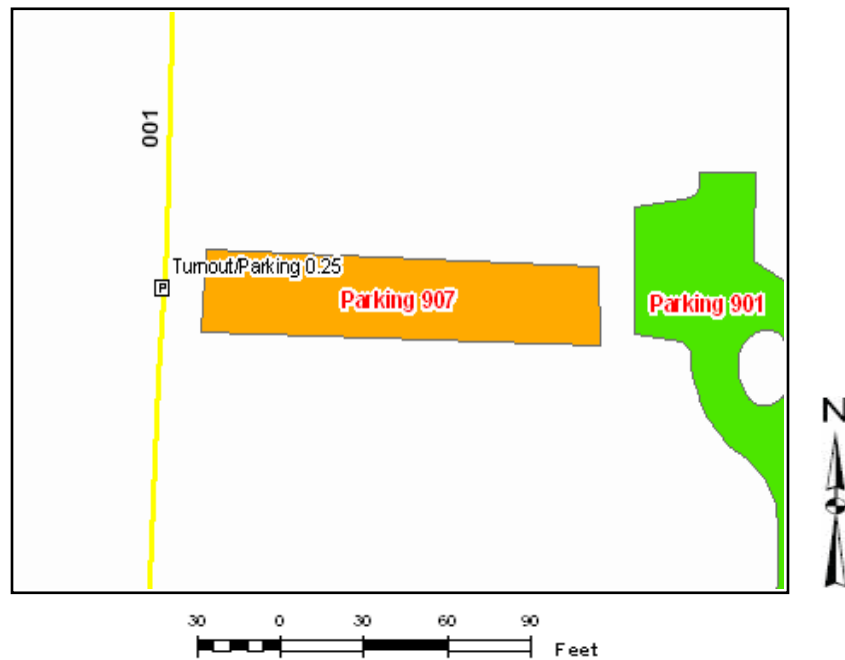
### 907: Headquarters Overflow Parking

Asset Number	Date Visited	Surface Type	Area (Sq Ft)	Condition	Cost to Improve
	06/02/2010	Asphalt	4,784	Poor	22,600

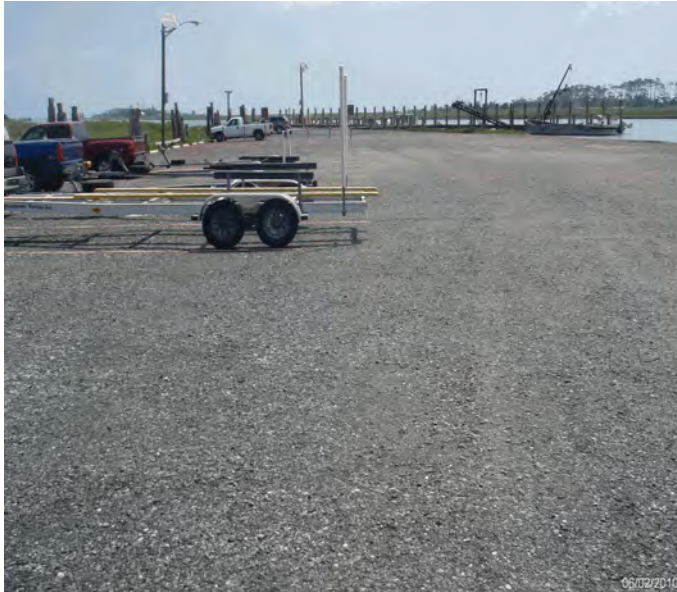
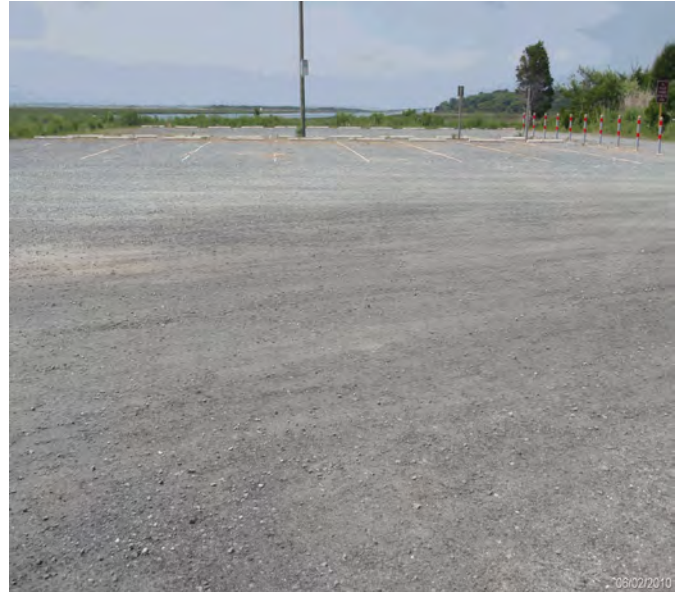
### 908: Wise Point Boat Ramp Parking

Asset Number	Date Visited	Surface Type	Area (Sq Ft)	Condition	Cost to Improve
10060027	06/02/2010	Gravel	76,077	Good	11,300

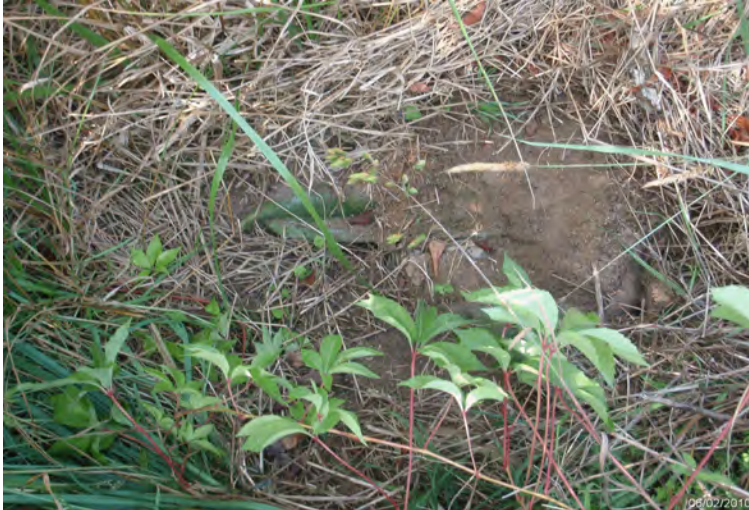
Photo # EaSh\_C4\_0570 - MP 0.00 - Round Culvert Section 001

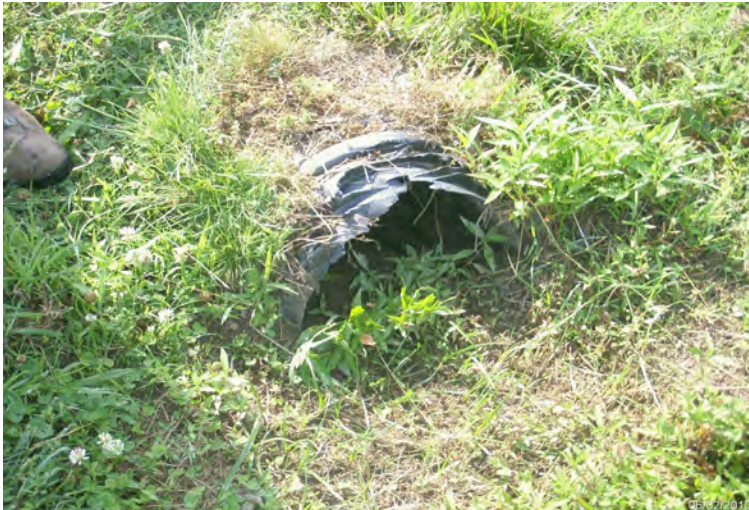
Photo # EaSh\_C4\_0572 - MP 0.14 - Round Culvert Section 001

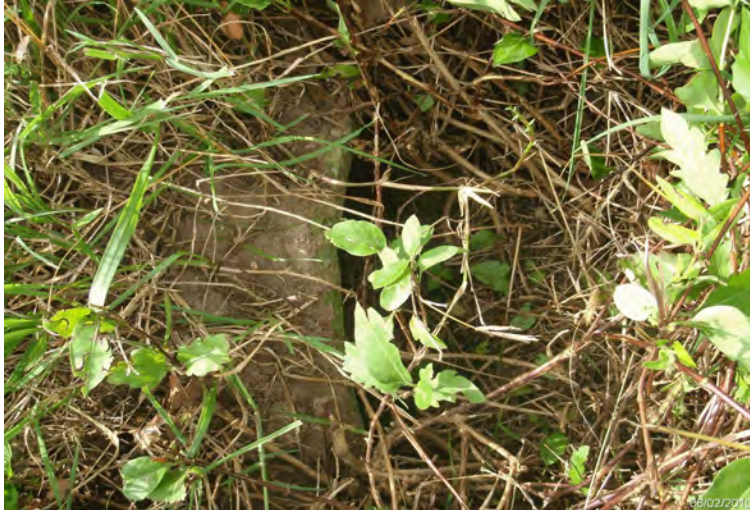
Photo # EaSh\_C4\_0577 - MP 0.00 - Round Culvert Section 001

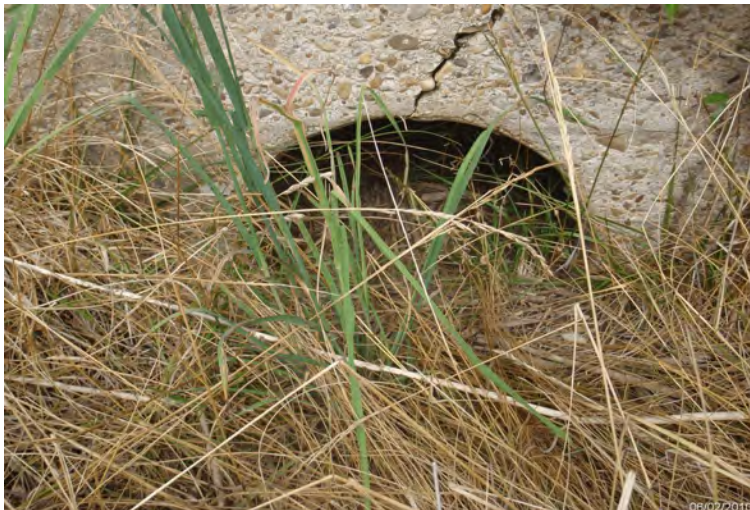
Photo # EaSh\_C4\_0583 - MP 0.37 - Round Culvert Section 001

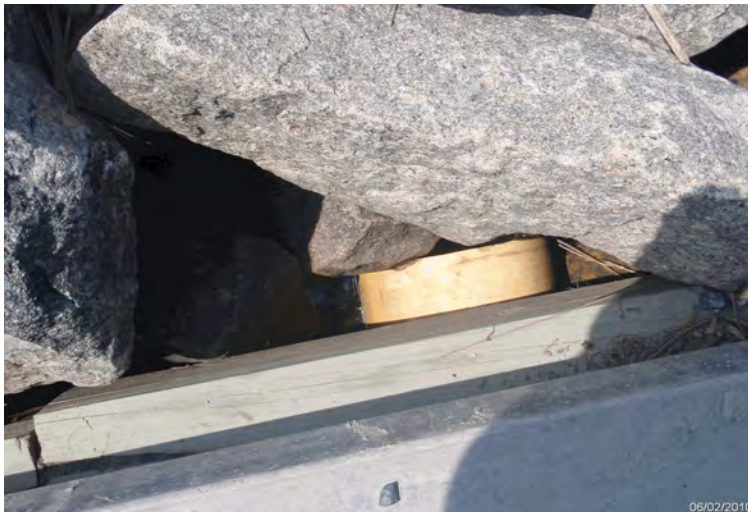
Photo # EaSh\_C4\_0600 - MP 0.18 - Round Culvert Section 001

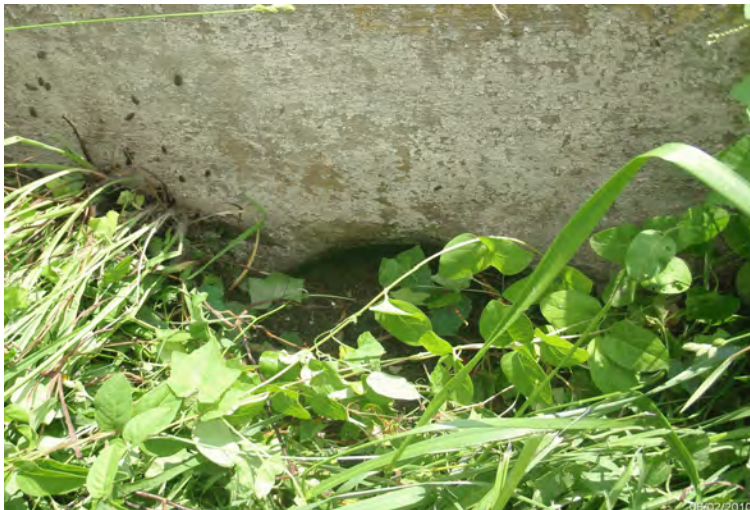
Photo # EaSh\_C4\_0609 - MP 0.55 - Round Culvert Section 001

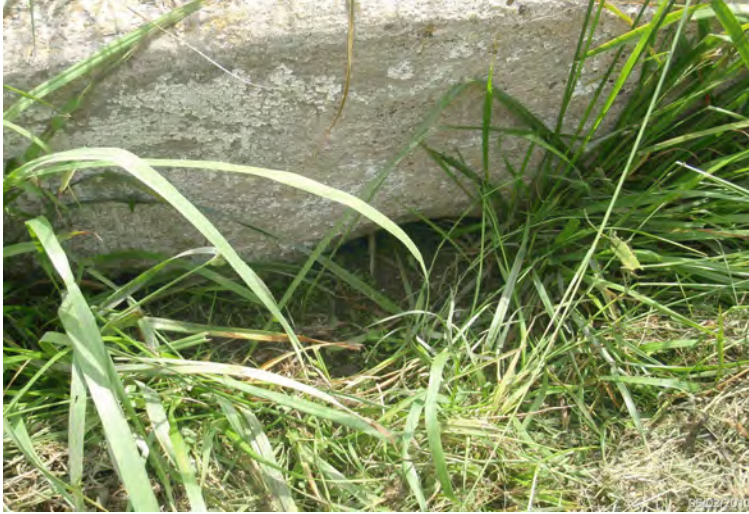
Photo # EaSh\_C4\_0611 - MP 0.65 - Round Culvert Section 001

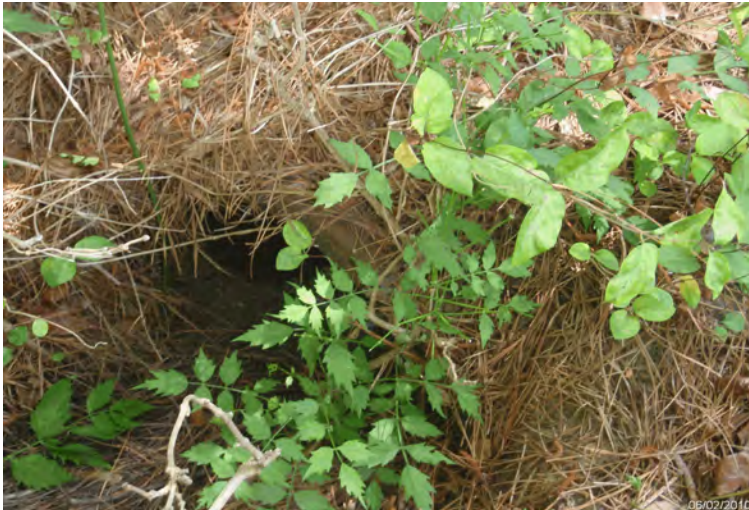
Photo # EaSh\_C4\_0620 - MP 0.37 - Round Culvert Section 001
